SMALL SCALE STUDIES OF THATCHED ROOFS IN ESTONIA

KRISTINA AKERMANN

ESTONIAN UNIVERSITY OF LIFE SCIENCES

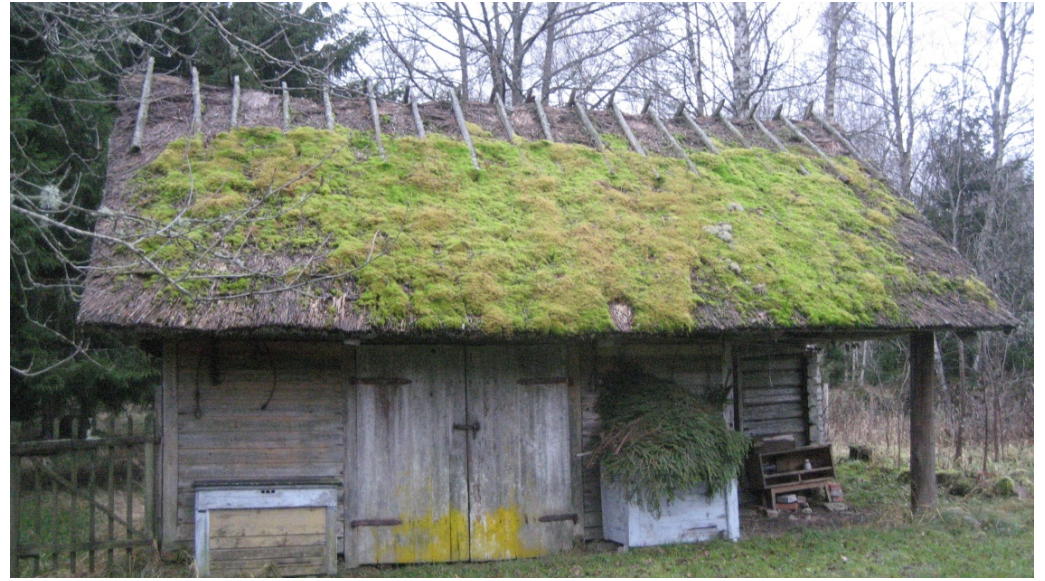
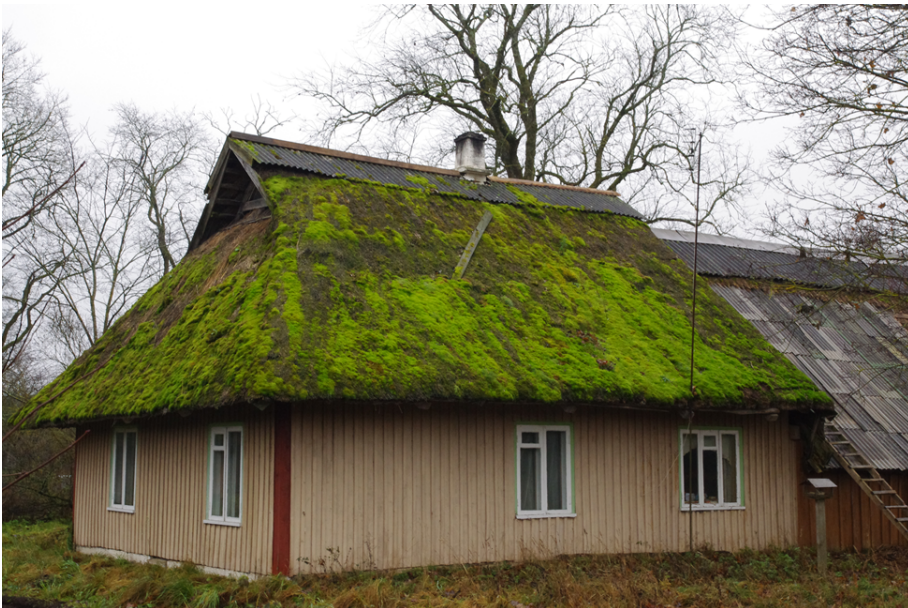
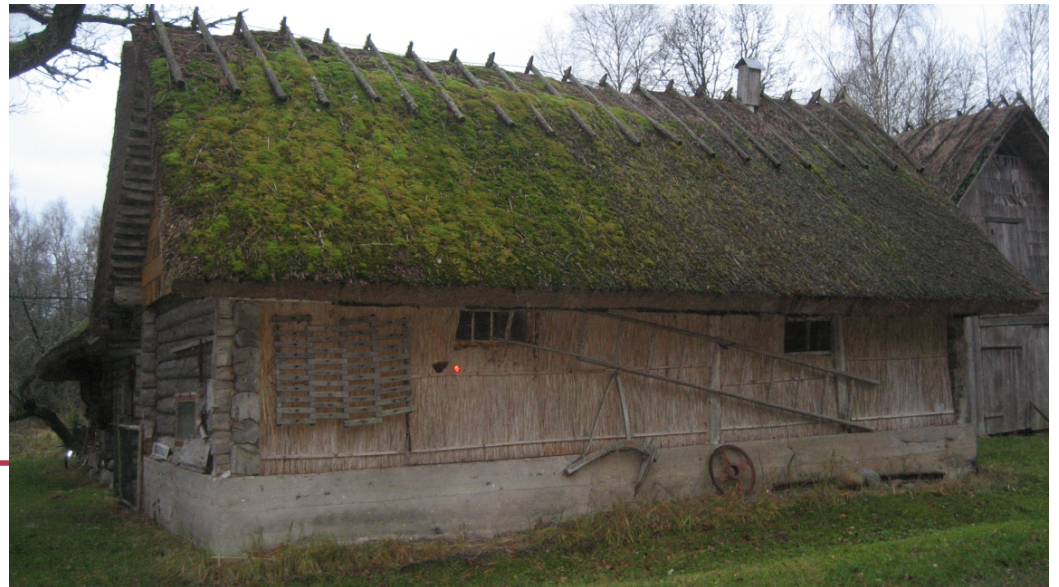
**A NUMBER OF THE OLD
THATCHED ROOFS ARE
COVERED WITH MOSS**

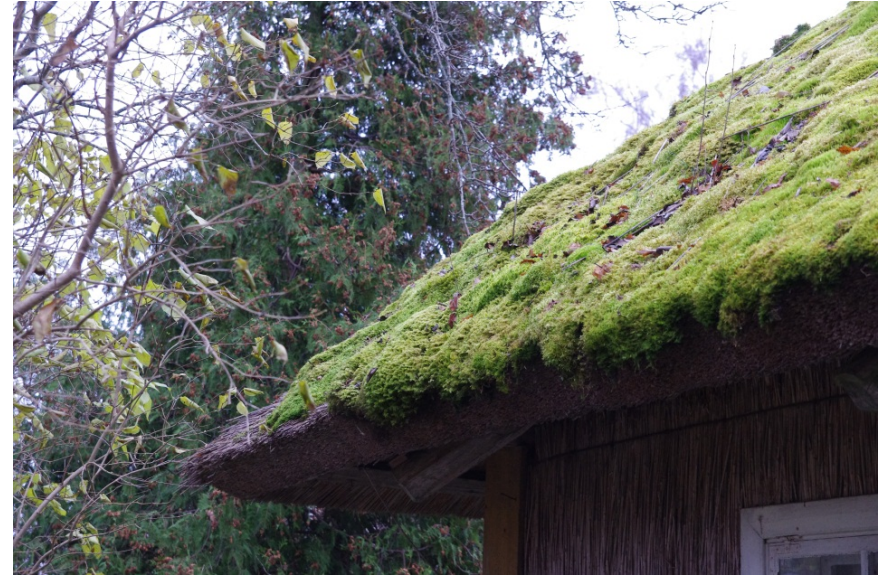
- The study showed that moss prefers to grow on the damp surfaces facing north.
- North sides of roofs were covered with moss ranging 15-75% compared to south side of roofs, which were covered with moss only 0-10 %.
- There was no significant difference in the representation of moss on east- and west-facing roof sides.

- It was found that shading trees magnify the growth of moss.

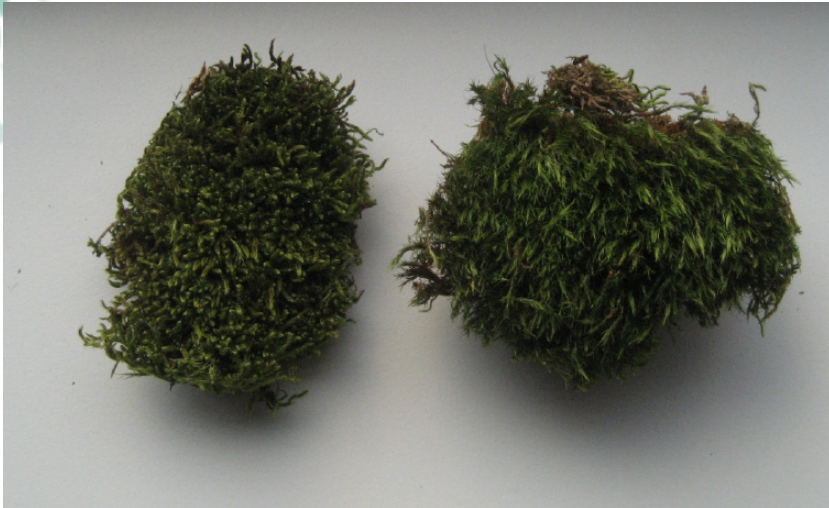
Hypnum cupressiforme (left) and *Dicranum scoparium* (right)

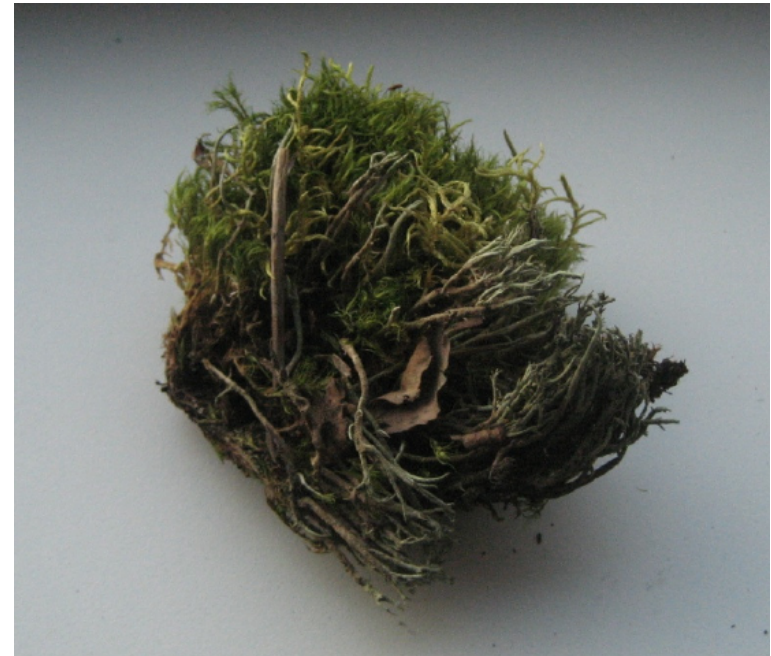
Dicranum scoparium, *Cladina rangiferina*, *Pleurozium schreberi*
